NATIONAL DAM INSPECTION PROGRAM. MIDDLE CREEK DAM (NDI NUMBER P--ETC(U)

6 National Dam Inspection Program.  
Middle Creek Dam (NDI Number PA-00731,  
DER Number 36-259), Susquehanna River  
Basin, Lancaster County, Pennsylvania.  
Phase I Inspection Report.

OVERVIEW  
MIDDLE CREEK DAM

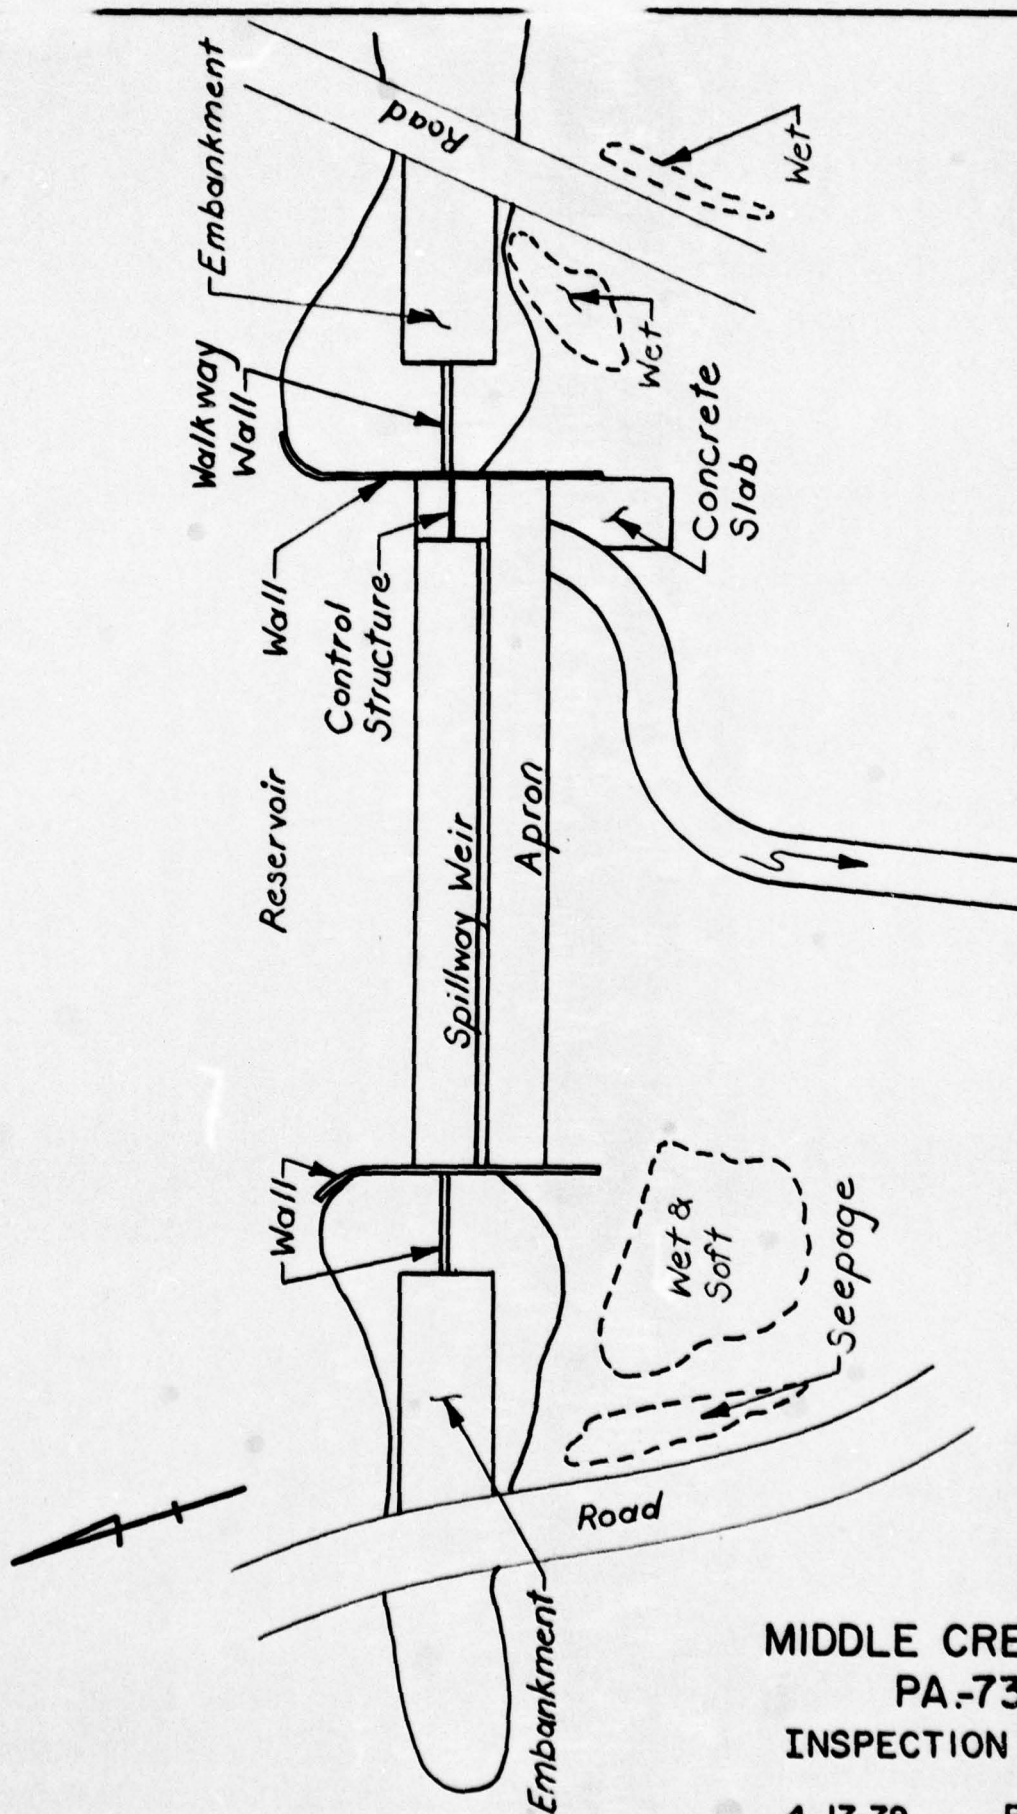
PLATE A-I

D. ALIGNMENT OF CREST: HORIZONTAL: VERTICAL:	Horizontal alignment - good. Good (Refer to Plate A-I, Appendix A).
E. RIPRAP FAILURES	None.
F. JUNCTION EMBANKMENT & ABUTMENT OR SPILLWAY	All junctions appear to be in good condition.

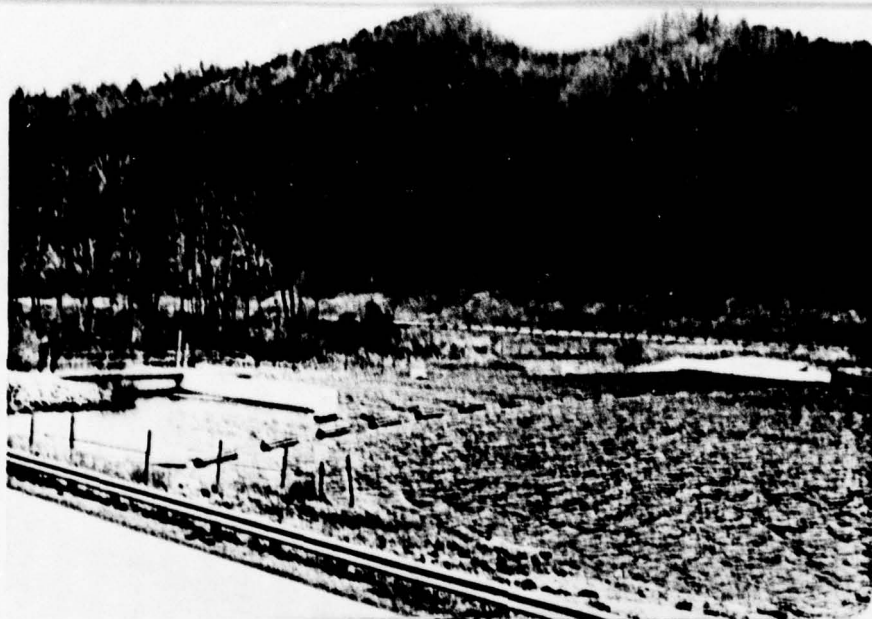
The embankment ties into the spillway sections with concrete walls which were in excellent condition. The wall on the left side carries a small walkway, to the control works, which is incorporated with the spillway section.

Forebay Walls

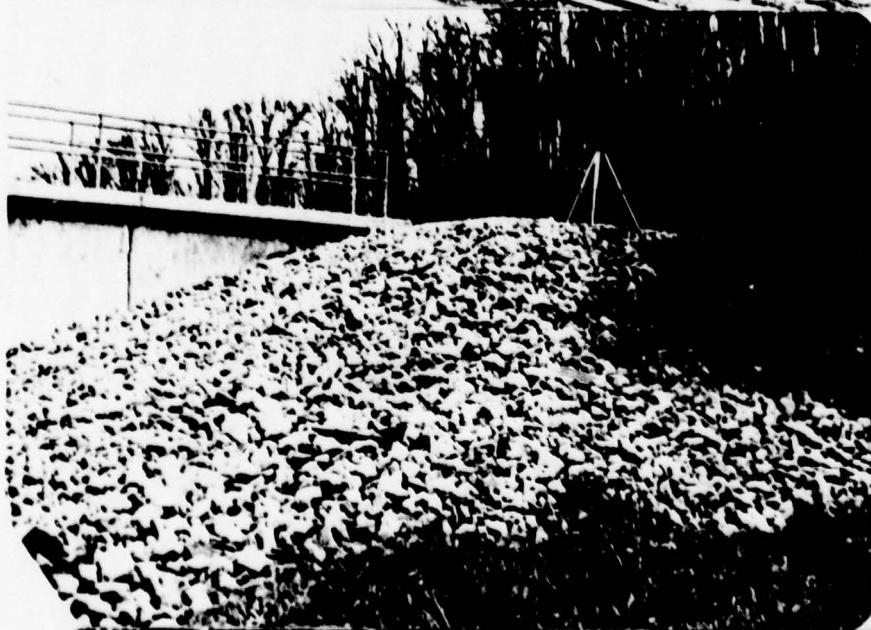
Left Abutment  
Downstream

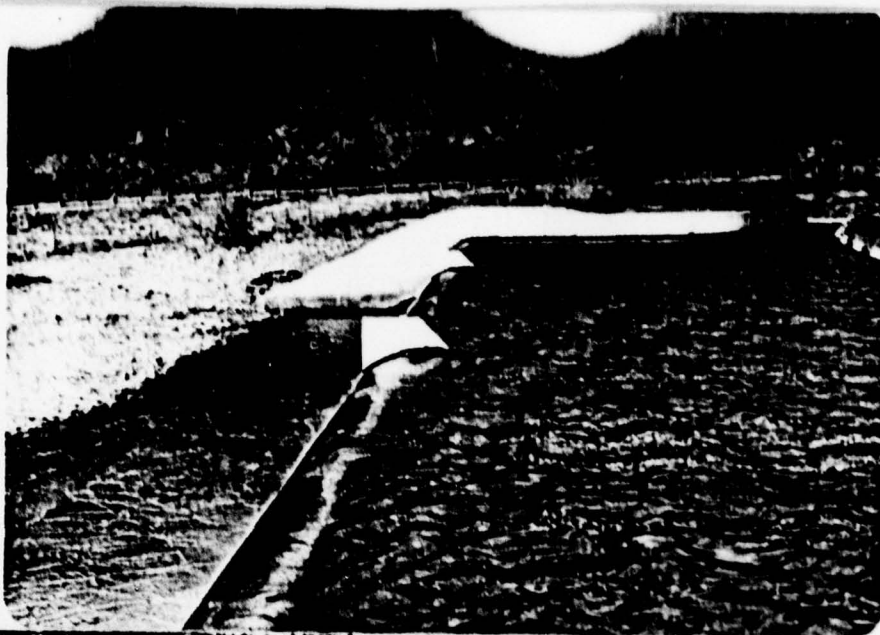
concrete surfaces appeared in good condition. The top of the weir has two small piers, acting as ice breaking devices. Although the flow of water was small, some tailwater was over the slab, thus, breaking the force of the falling water.

Spillway Overflow  
and  
Ice Breakers

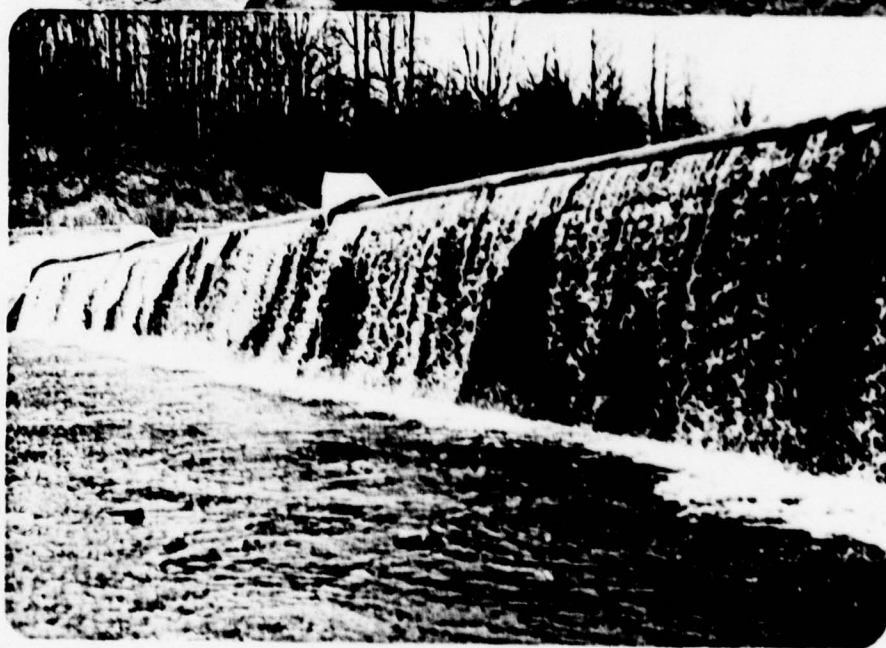
The spillway and the operational facilities are all in good condition. The visual observation did not notice any problems in stability or wall movements. All concrete surfaces were in excellent condition. Downstream erosion has not occurred.

Downstream View  
of  
Spillway

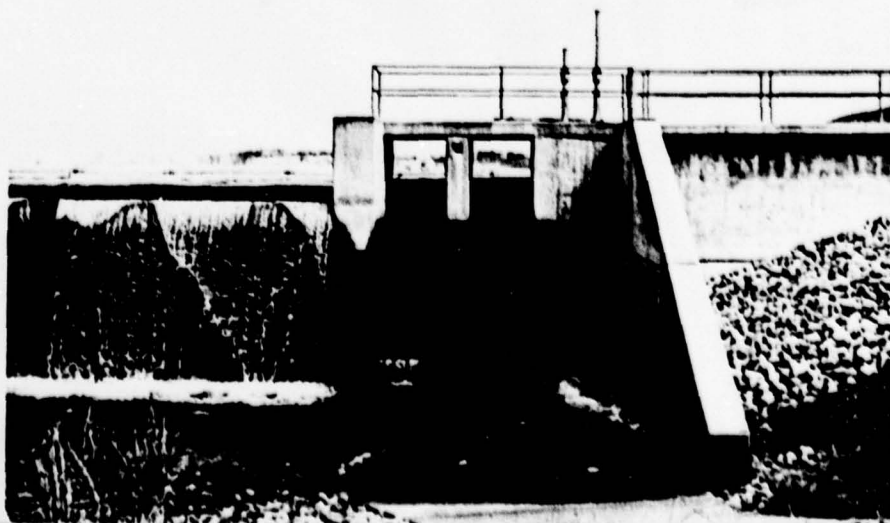
Left Side of  
Spillway  
With  
Control Structure

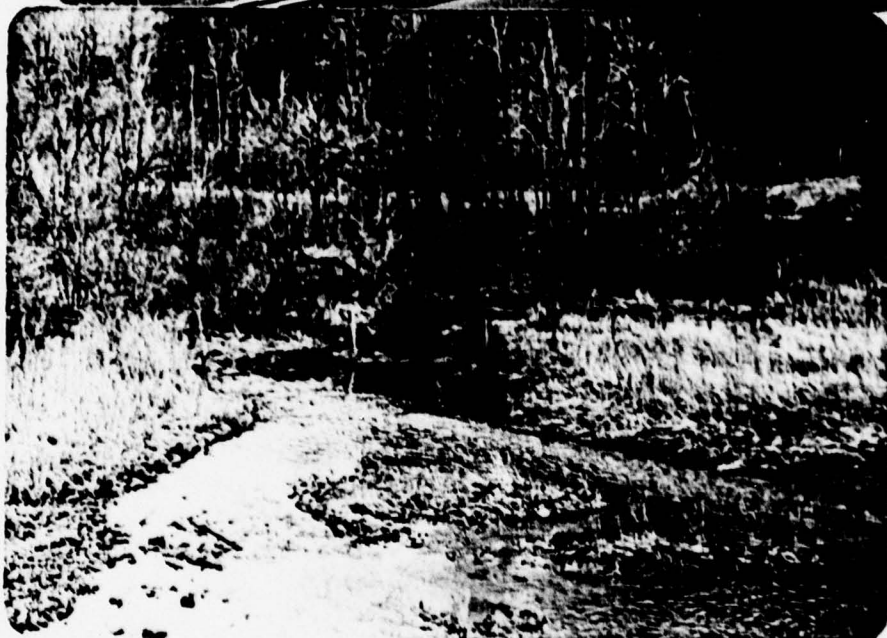
Downstream Channel

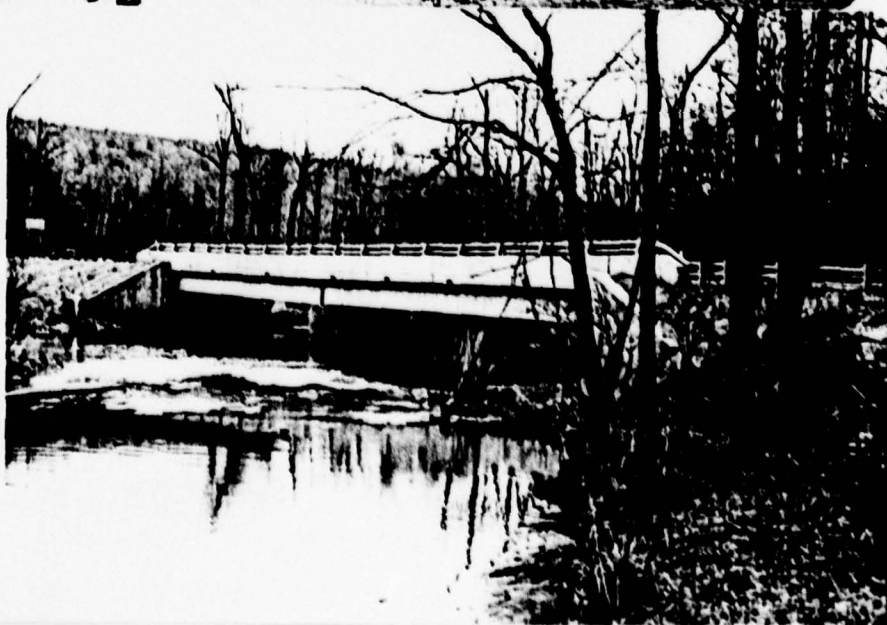
The designer had evaluated the effect of the bridge located just downstream of the dam, and determined that the resulting backwater from the design flood would cause the tailwater at the dam to be at about elevation 542.9. This would not affect the discharge capacity.

Two Span Bridge  
Downstream Channel
